Focus on IFA's work

Issue: 12/2024

Acoustic trauma caused by disconnection of a compressed air line

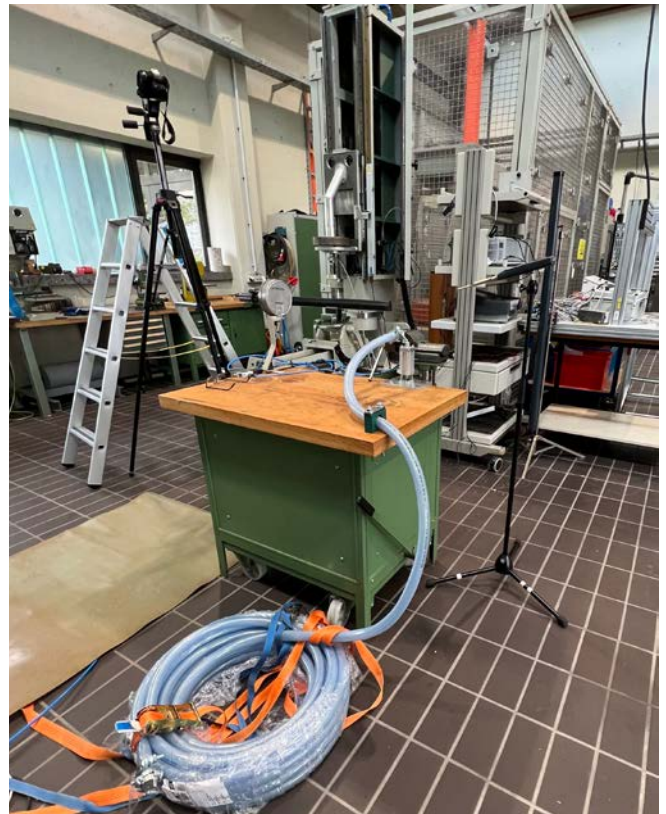
In a test arrangement set up specially for the purpose, the IFA's experts adjusted the key parameters of the line cross-section and length, the type and model of coupling used and the pneumatic pressure to the conditions of the incident. The controlled laboratory environment enabled the incident to be reproduced safely.

Test set-up for simulation of the incident

A number of test series were performed in order to eliminate various uncertainties in the course of the incident and deliver reliable results. Based on the results of the calculations carried out beforehand, suitable measurement equipment was selected for reliable determination of the sound pressure levels arising at different pressures and at different distances from the source of the detonation.
